Limited Visual Dam Safety Inspection Summary Report

MA-092

Papaaea Reservoir

Limited Visual Dam Safety Inspection Conducted on: 05 April 2006

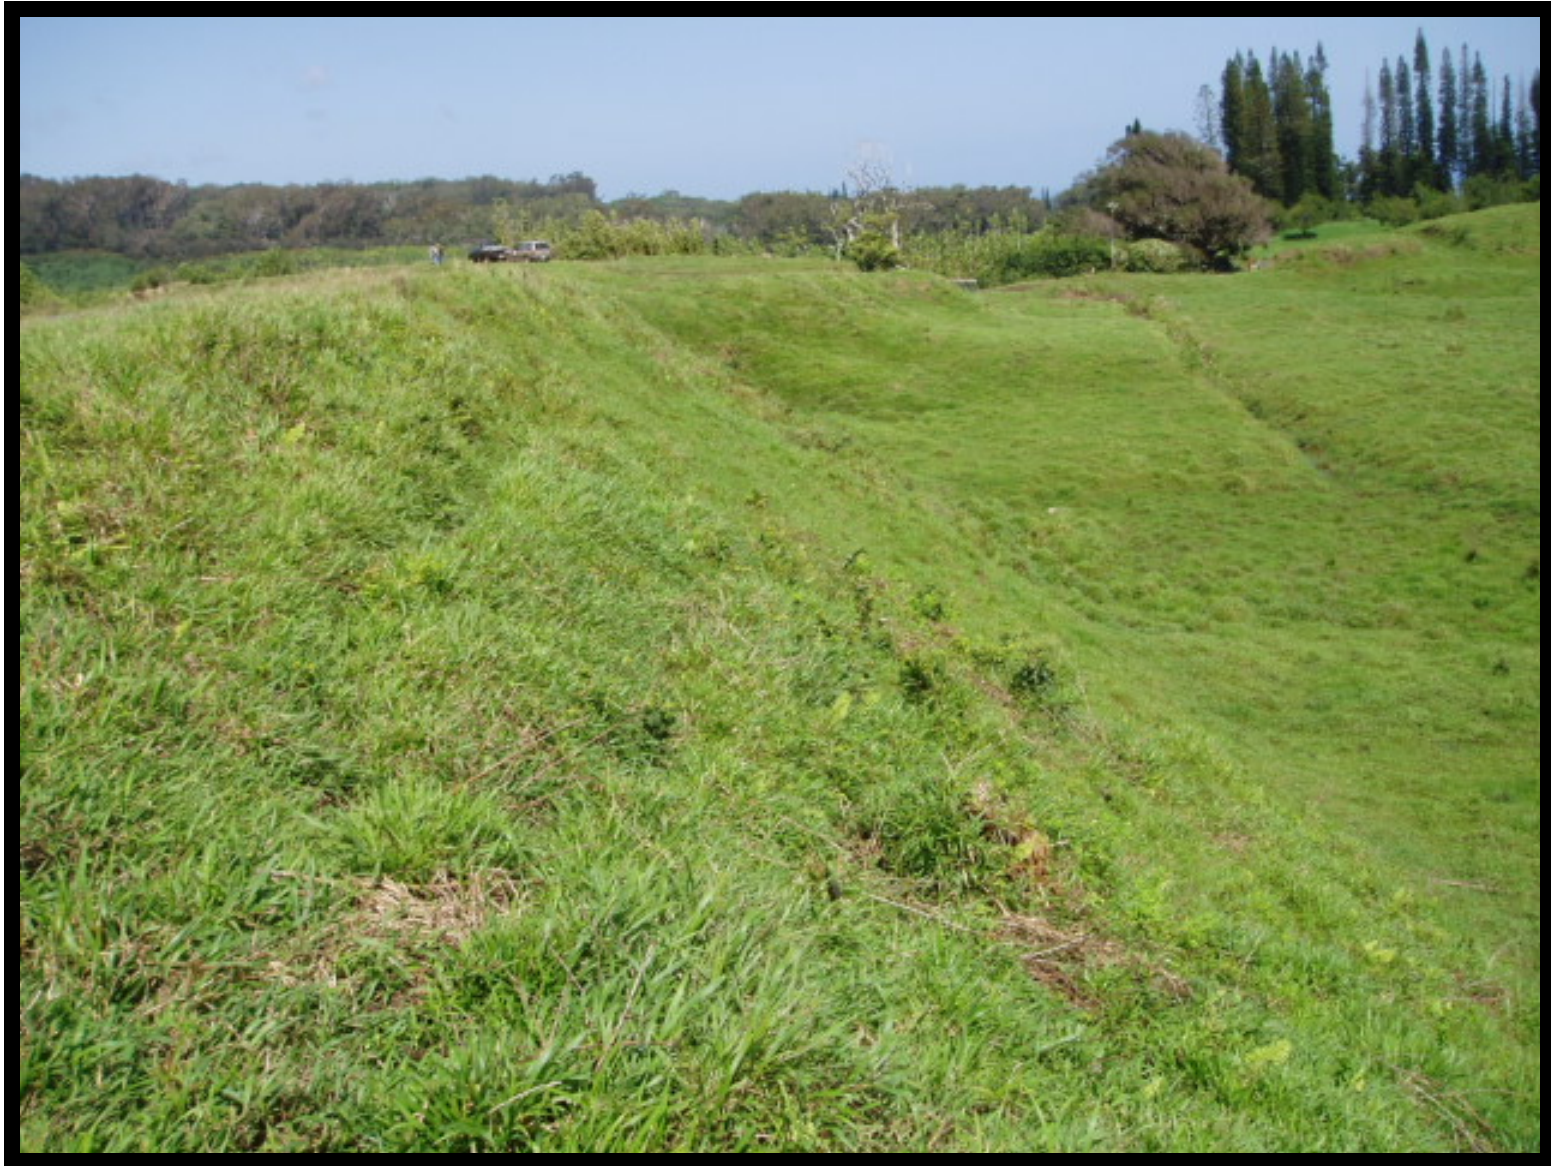
- a. The downstream slope appeared to be in fair to poor condition and requires corrective action.
- b. The slope was very steep, around a 1 to 1 slope; further study is required to verify slope stability.

092 downstream 1 - Downstream slope of the dam. Short grass covers the slope. Vegetation management is excellent.

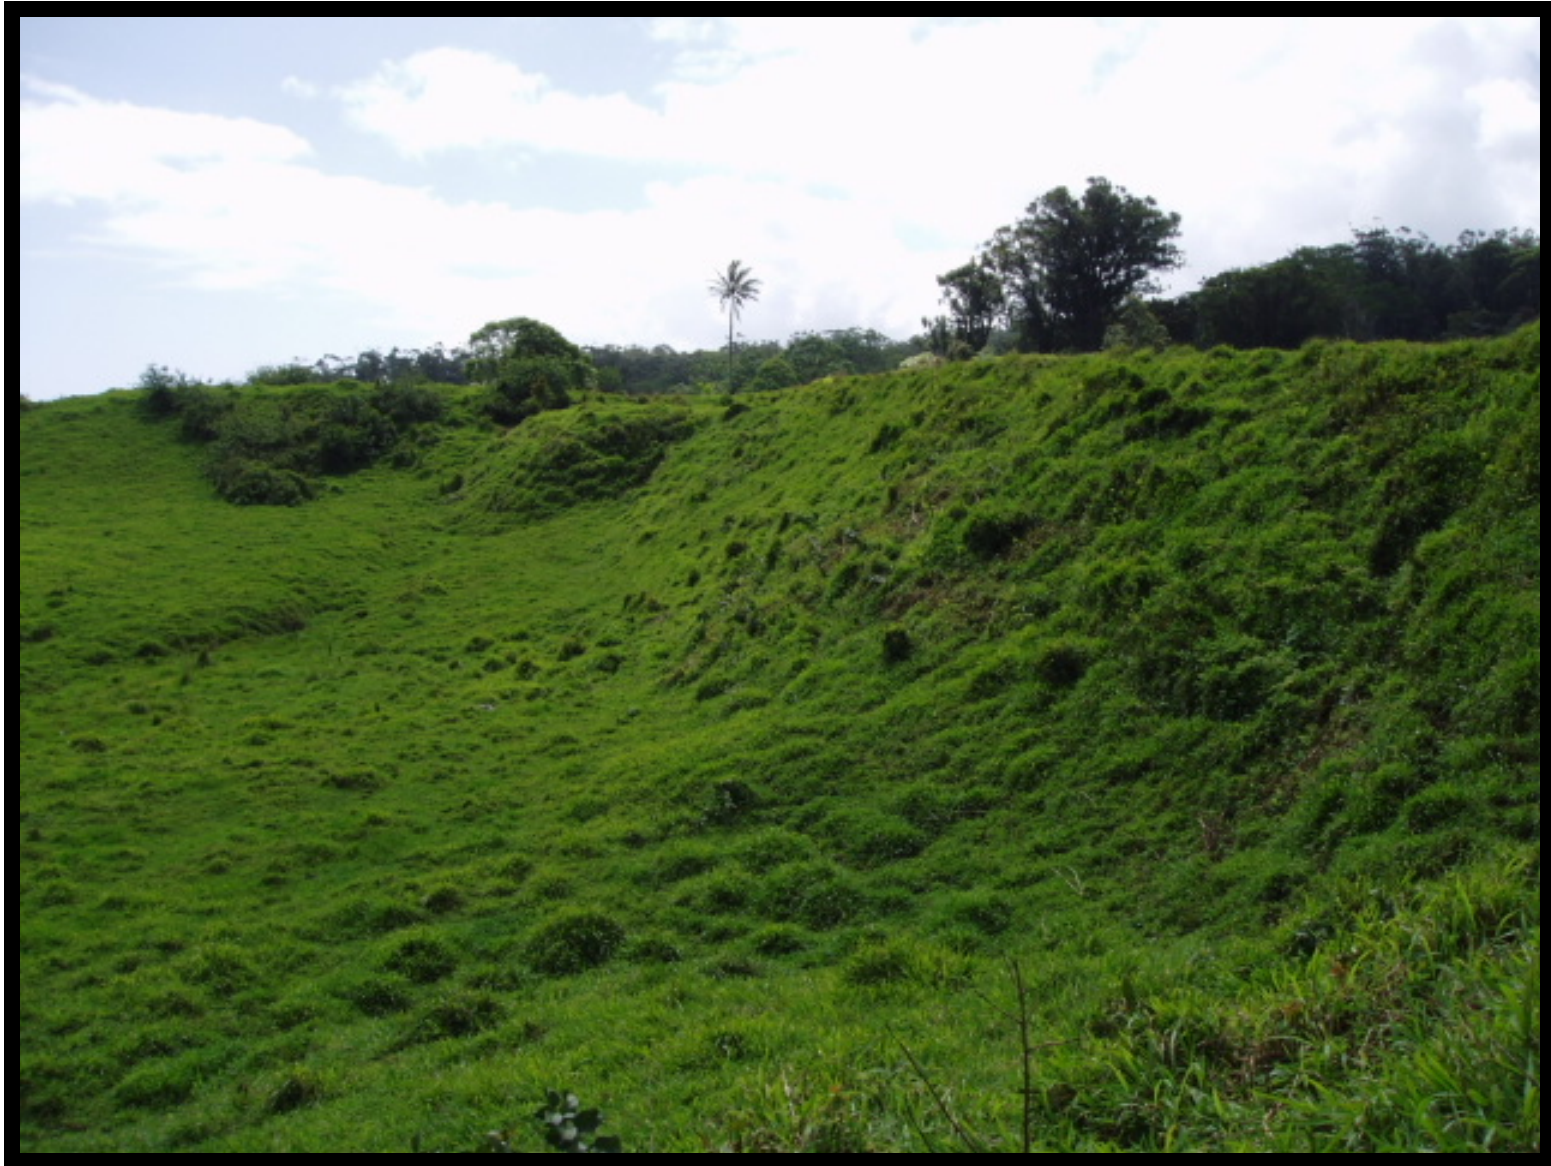
092 downstream 2 - Downstream slope of the dam. Short grass covers the slope. Vegetation management is excellent.

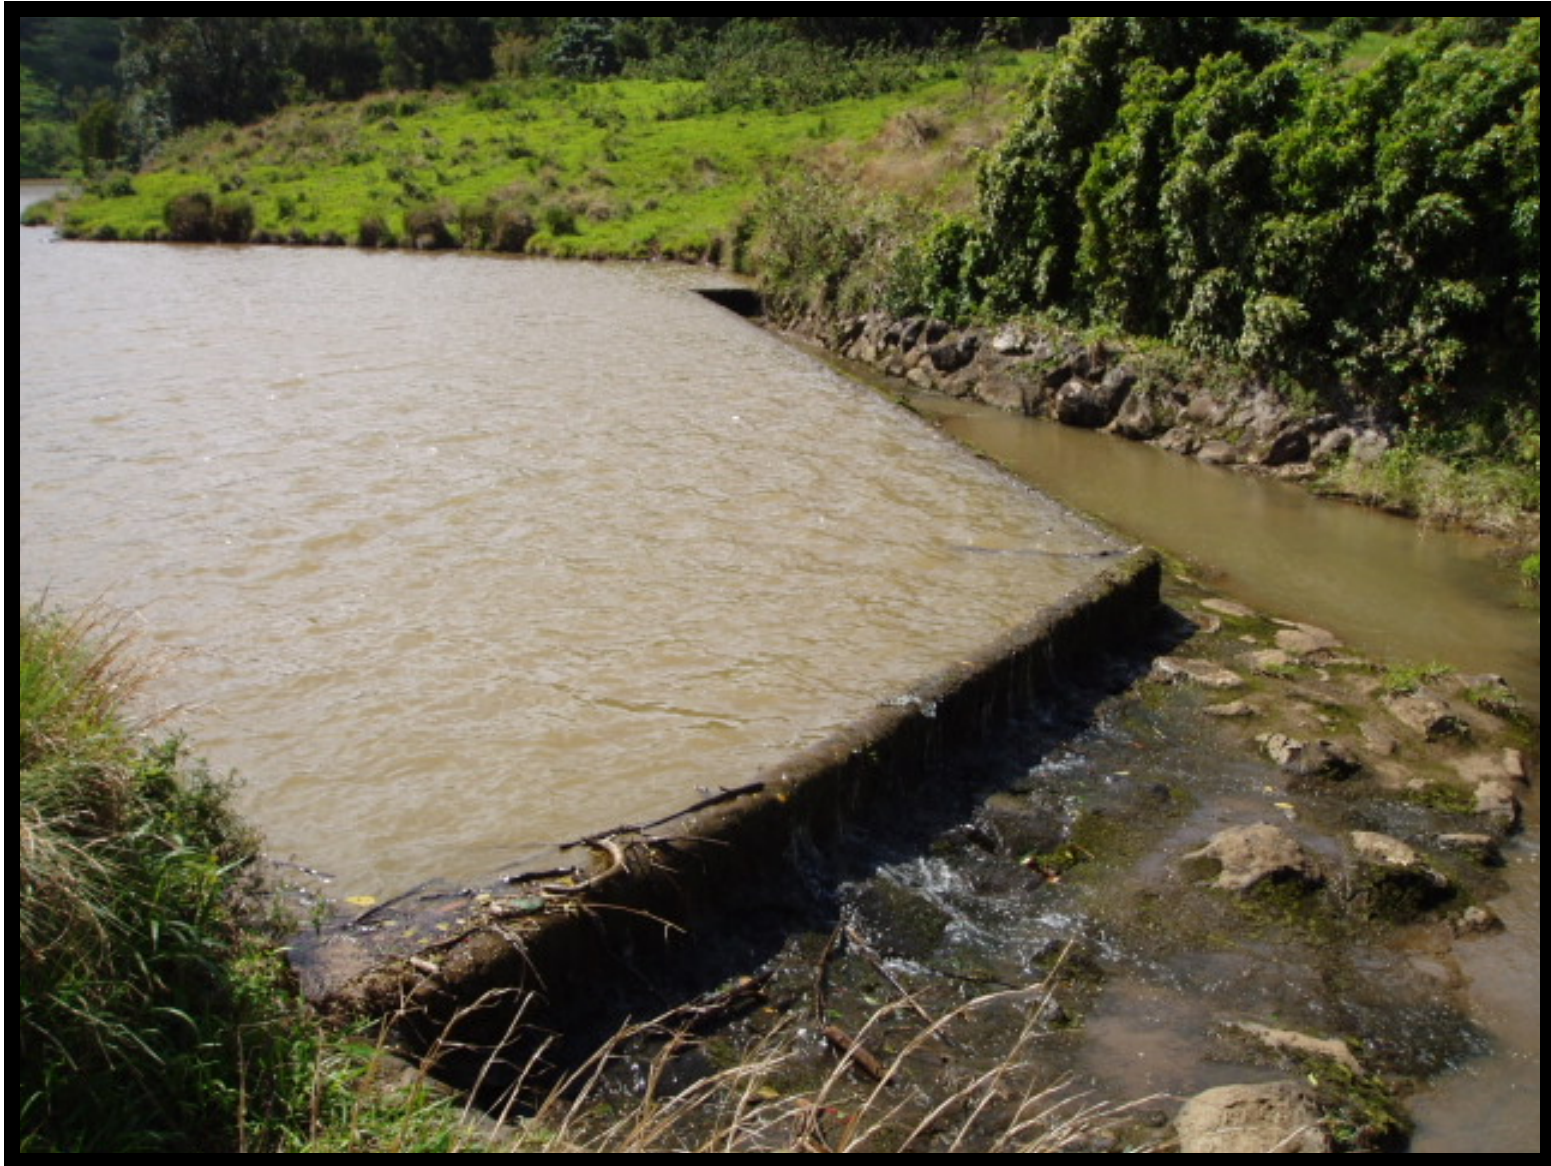
- a. The Spillway appeared to be in satisfactory condition, no corrective actions are required at this time.

092 spillway - Reservoir is full with a trickle of water flowing over the sill.

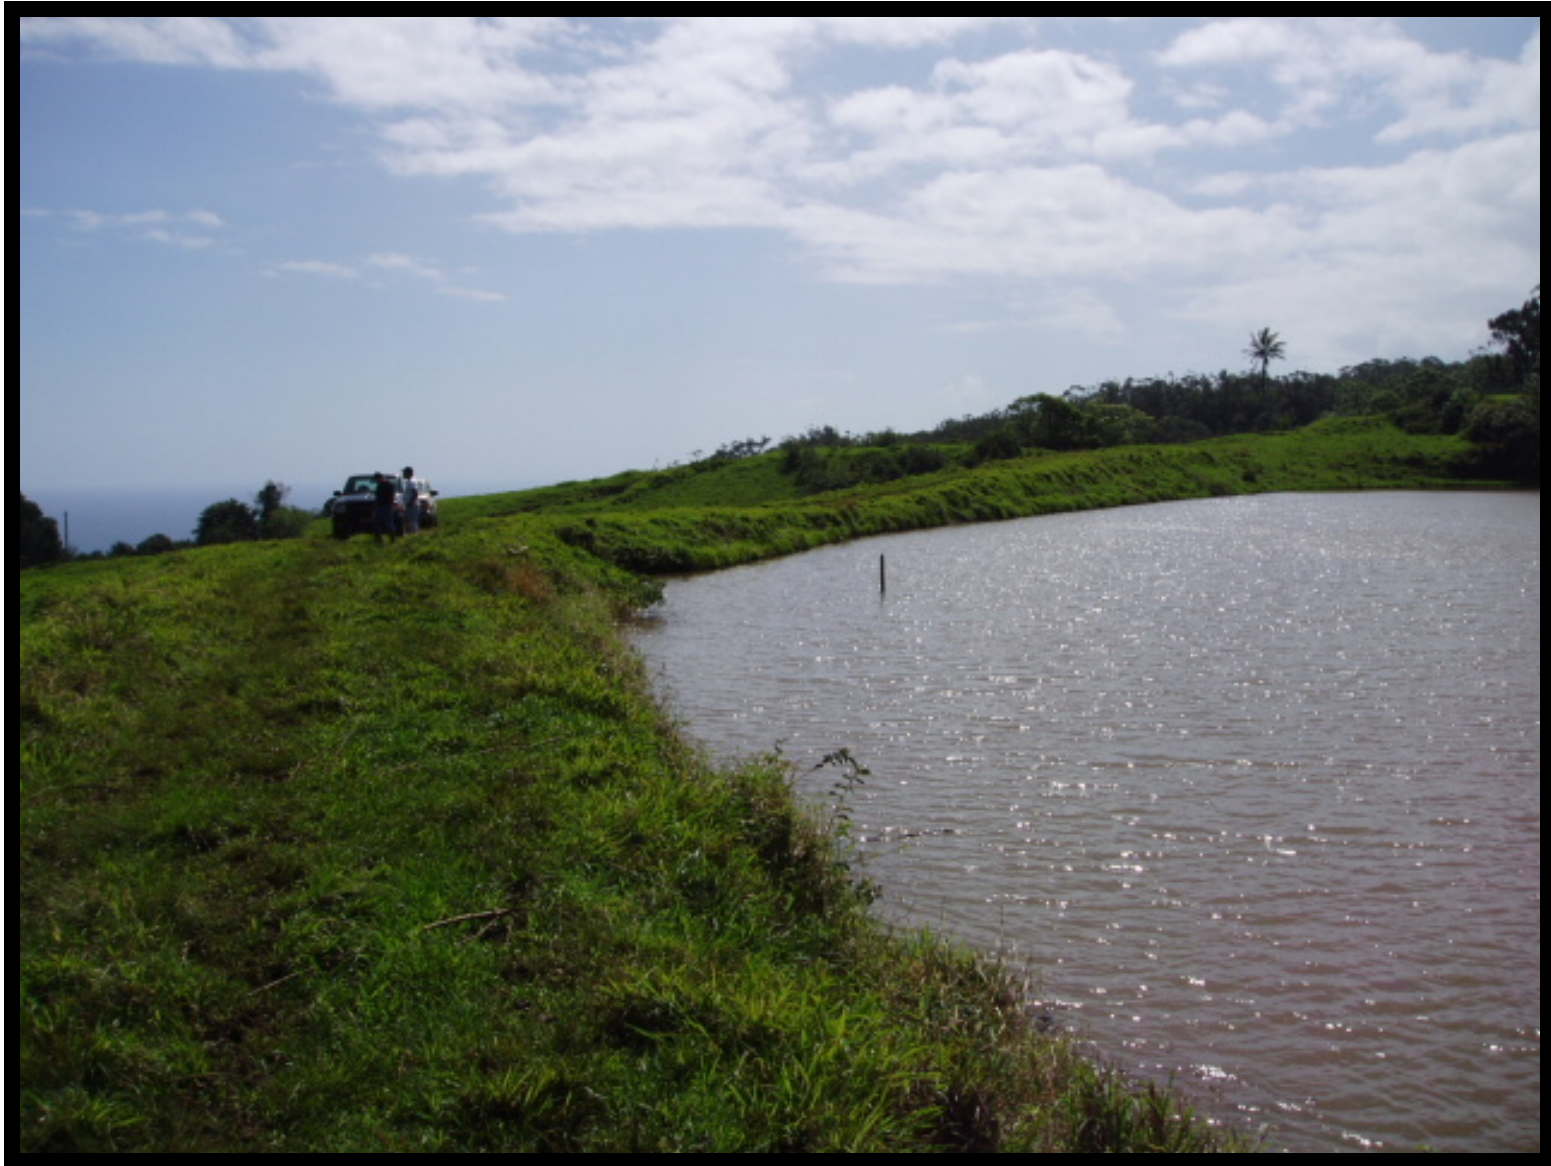
- a. The upstream slope appeared to be in satisfactory condition, no corrective actions are required at this time.

092 upstream slope of the dam
